Traumatic asphyxial death from two-wheel 'walking behind' tractor

We present a case of death by chest compression without other fatal factors. The force causing the chest compression was distinctly determined by the autopsy and scene investigation.

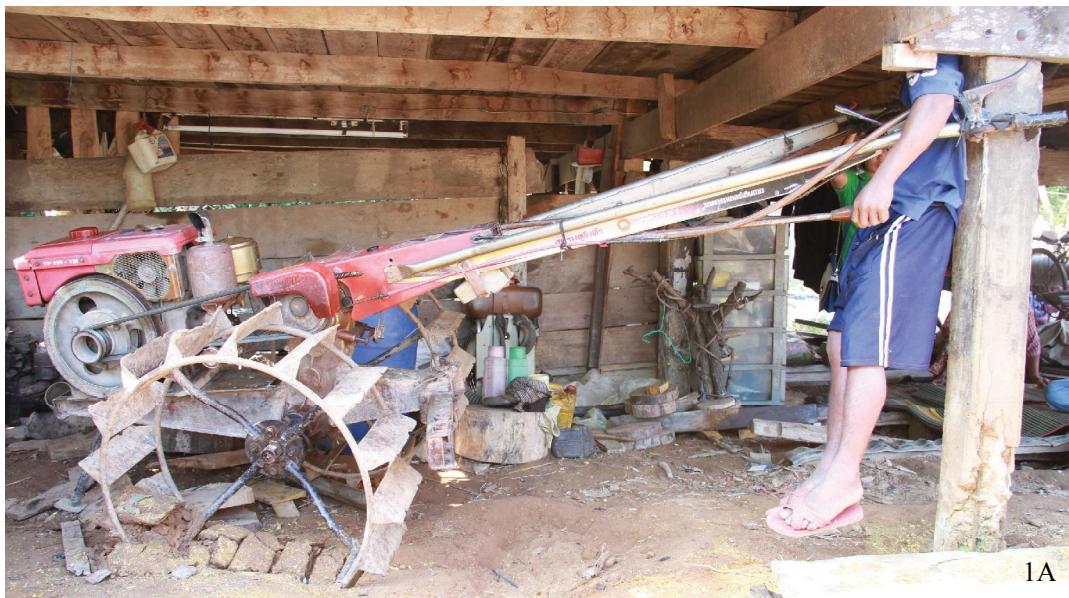
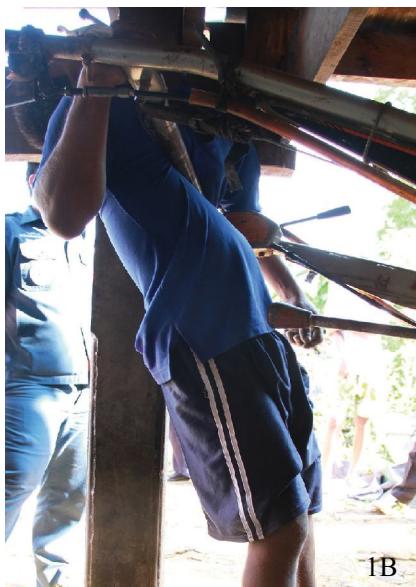
A 41-year-old man was found suspended 15 cm above the floor of the space under the house, compressed by the long handle bars of a two-wheel 'walking behind' tractor. He was in a vertical position compressed against a pillar (Figure-1) and

Figure 1 1A and 1B: Victim compressed by handle-bar of two-wheel walking behind tractor with pillar of the basement.

We proposed that this accident was due to the matter that the victim started the engine and drove the tractor out of the site by changing gear into reverse position by mistake. The machine became out of control and pushed the victim's body back against the pillar and upward against the low ceiling. He was thereby crushed into the suspended position as seen in the scene.

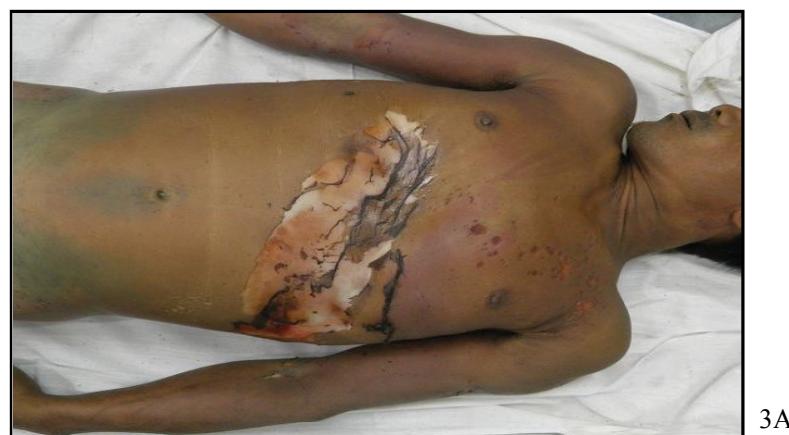
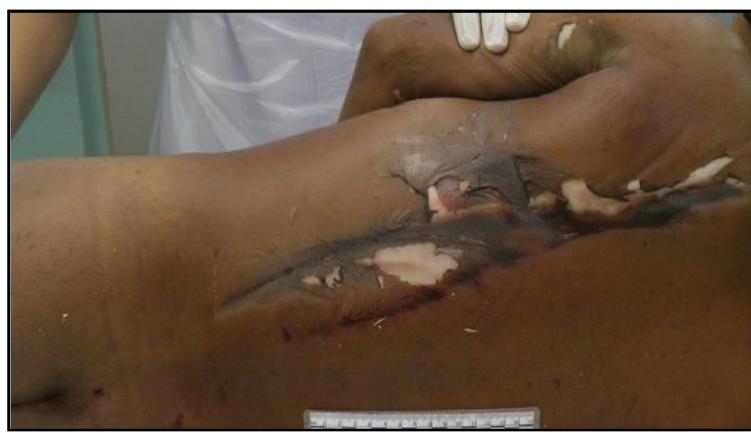
Figure 3 3A and 3B: Showing the linear postmortem abrasion on the front and back of chest wall

On gross physical examination; the face, neck and upper part of the chest were congested and petechial hemorrhages were observed on the conjunctivae and skin around the eyelids with prominent lividity on both legs. Postmortem abrasions were found along the epigastrium and just below the left chest wall area in transverse fashion measuring 10x20 cm. A group of postmortem insect-bite wounds on the left upper chest wall measured 0.4-1.0 cm in diameter. Postmortem abrasions along the left side of the back in longitudinal fashion measured 4x50 cm. Greenish discolored skin was observed on the lower abdomen. Intramuscular and subcutaneous hemorrhages were present in the chest wall during autopsy. The left sixth to tenth and the right fourth to ninth ribs showed fracture-sites on the anterior aspect and adjacent to the spine. The fractures were accompanied by minimal bleeding in the surrounding soft tissues and muscles. The brain weighed 1,200 g with normal appearance on both gross and microscopic examination. Gross examination of both lungs revealed congestion with moderate contusion areas at both lower lobes. The microscopic examination of the lung tissue showed interstitial and alveolar hemorrhage. Tracheal mucosa showed no abnormality and no airway obstruction. The heart weighed 220 g. There was no abnormal pathology in gross and microscopic appearance. The aortic arch and valves appeared normal. All organs in the abdomen were severely congested with early decomposition.
